An Taisce
The National Trust for Ireland

Buildings at Risk

November 2014

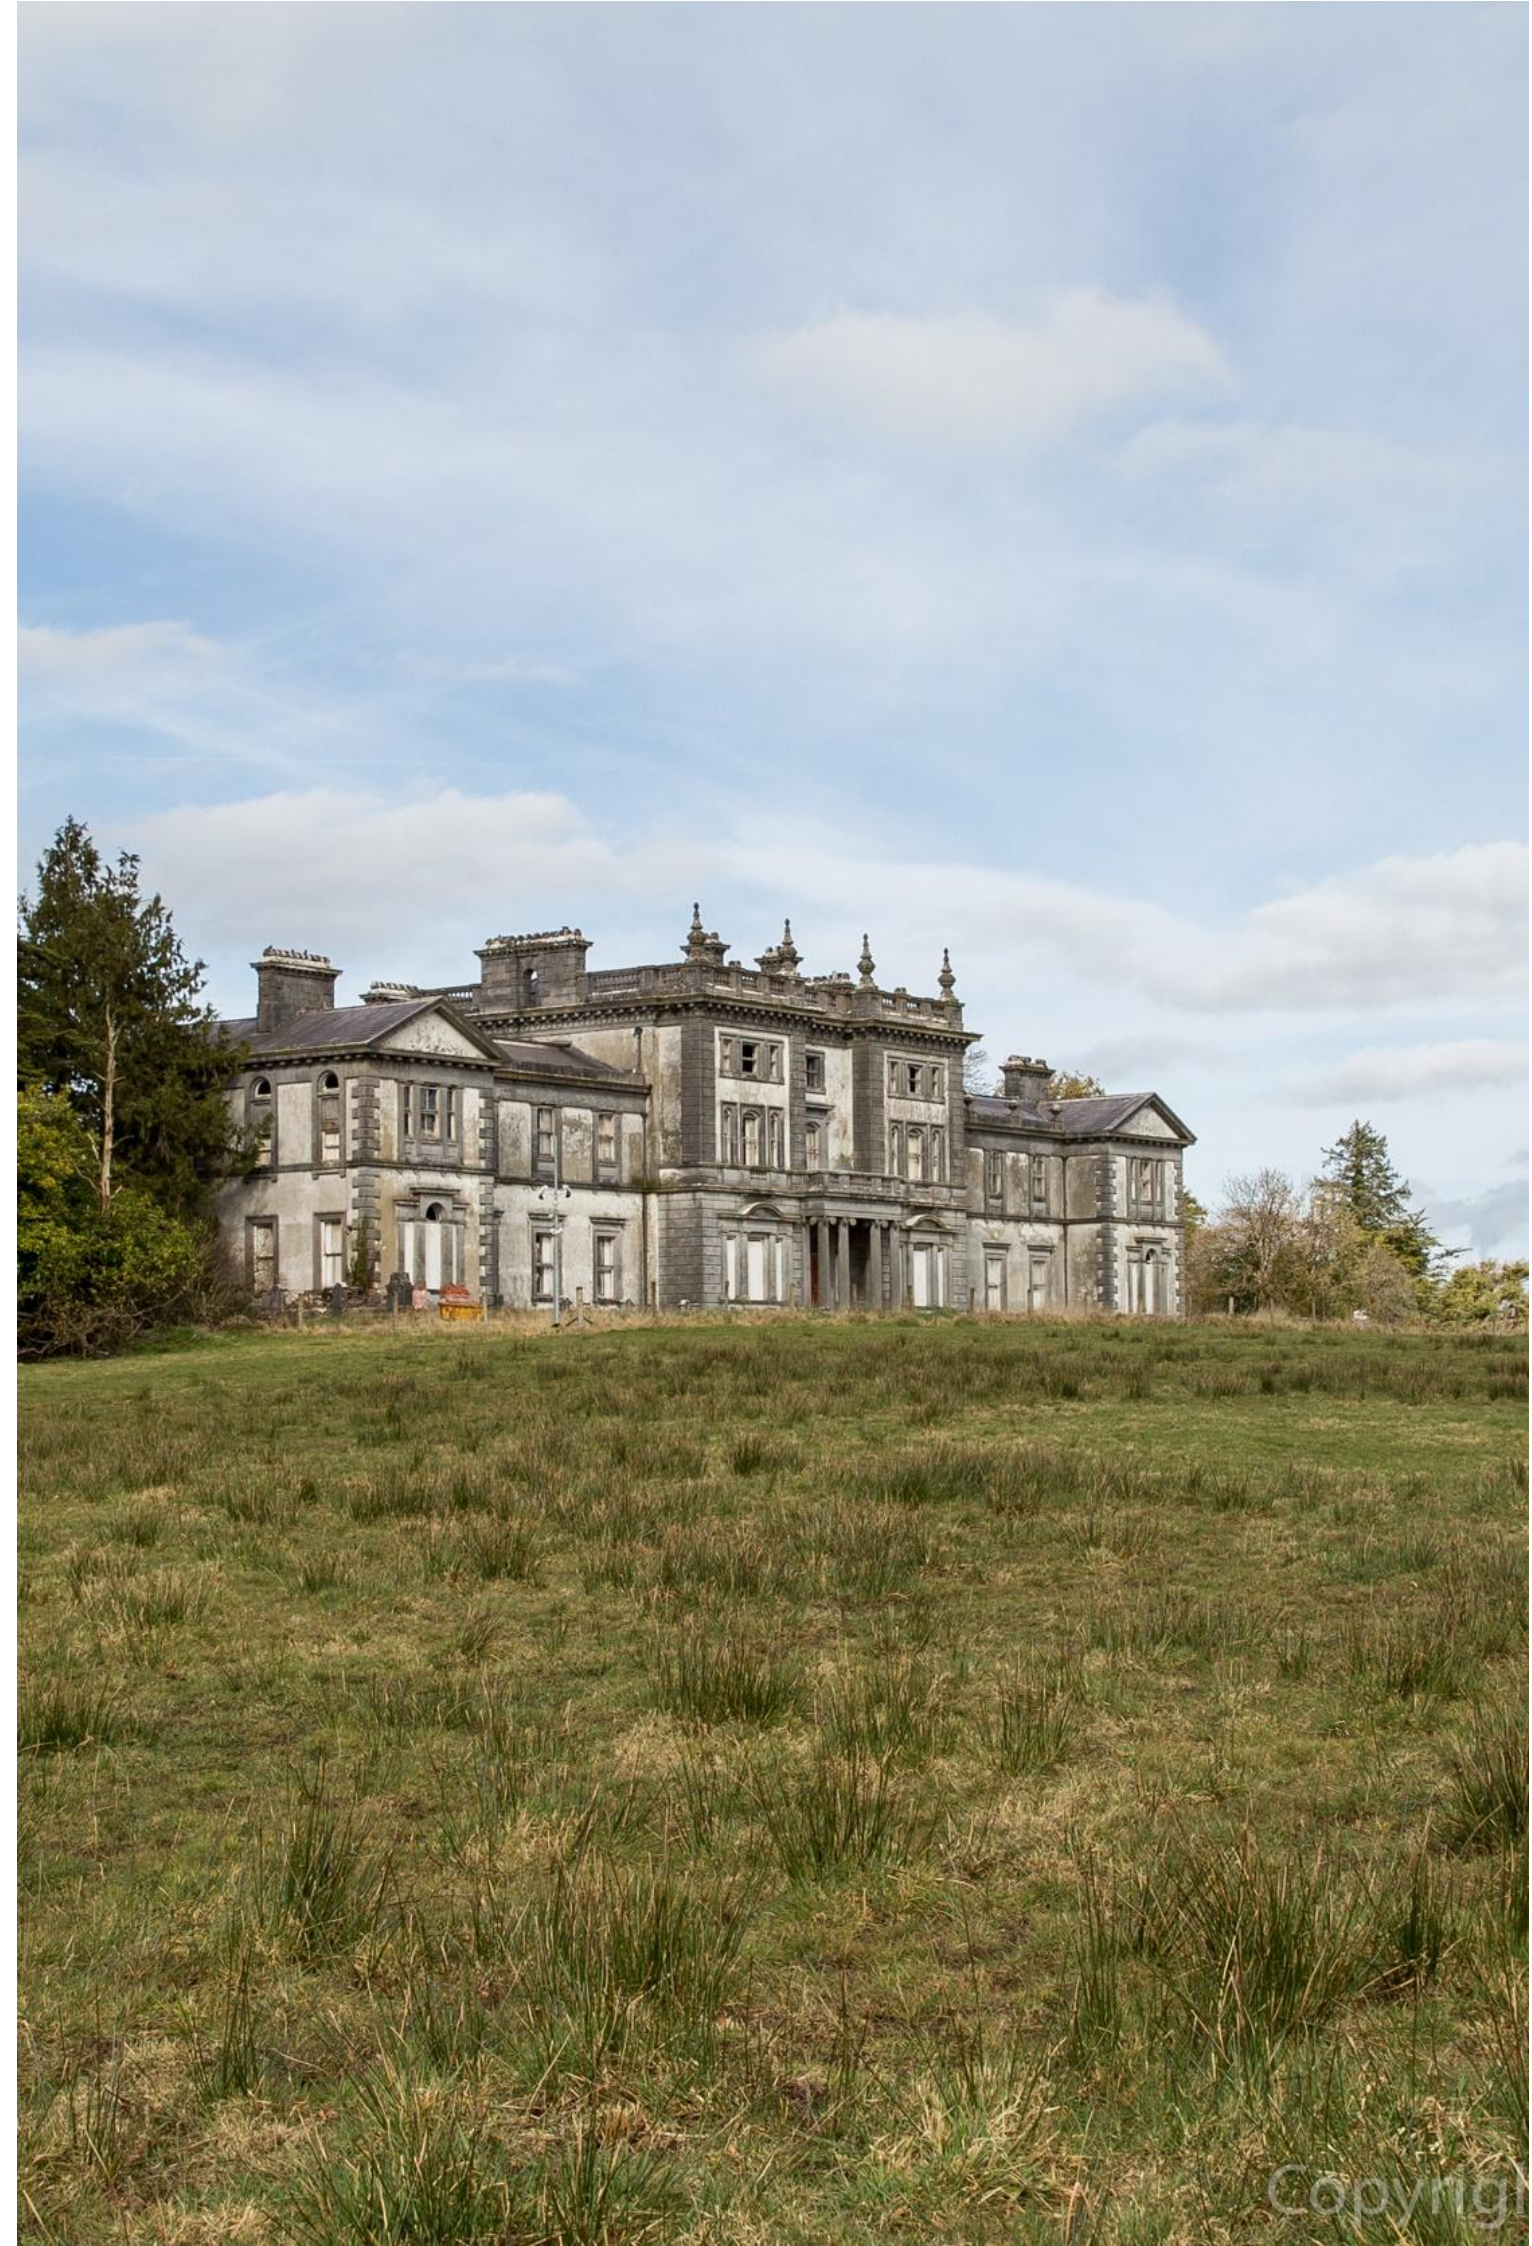
St Finian's Hospital

Vacant with no identified new use	X
Suffering from neglect and/or poor maintenance	
Suffering from structural problems	
Fire damaged	
Threatened with demolition	
Ruin which is poorly maintained

Condition of Structure	Good
Level of Risk	Moderate

The building fabric is generally sound, and its overall condition does not necessarily place it at risk. However, its future sustained use is in doubt.

The most architecturally distinguished of the 19th century Irish mental hospitals to the design of Sir Thomas Deane. The strongly modelled architectural composition with triple gabled central block and long multi gabled wings with later additions is an attractive example of use of local stone with limestone dressings. HSE is due to vacate the building. This building urgently requires new uses to be identified to prevent further deterioration of its character.

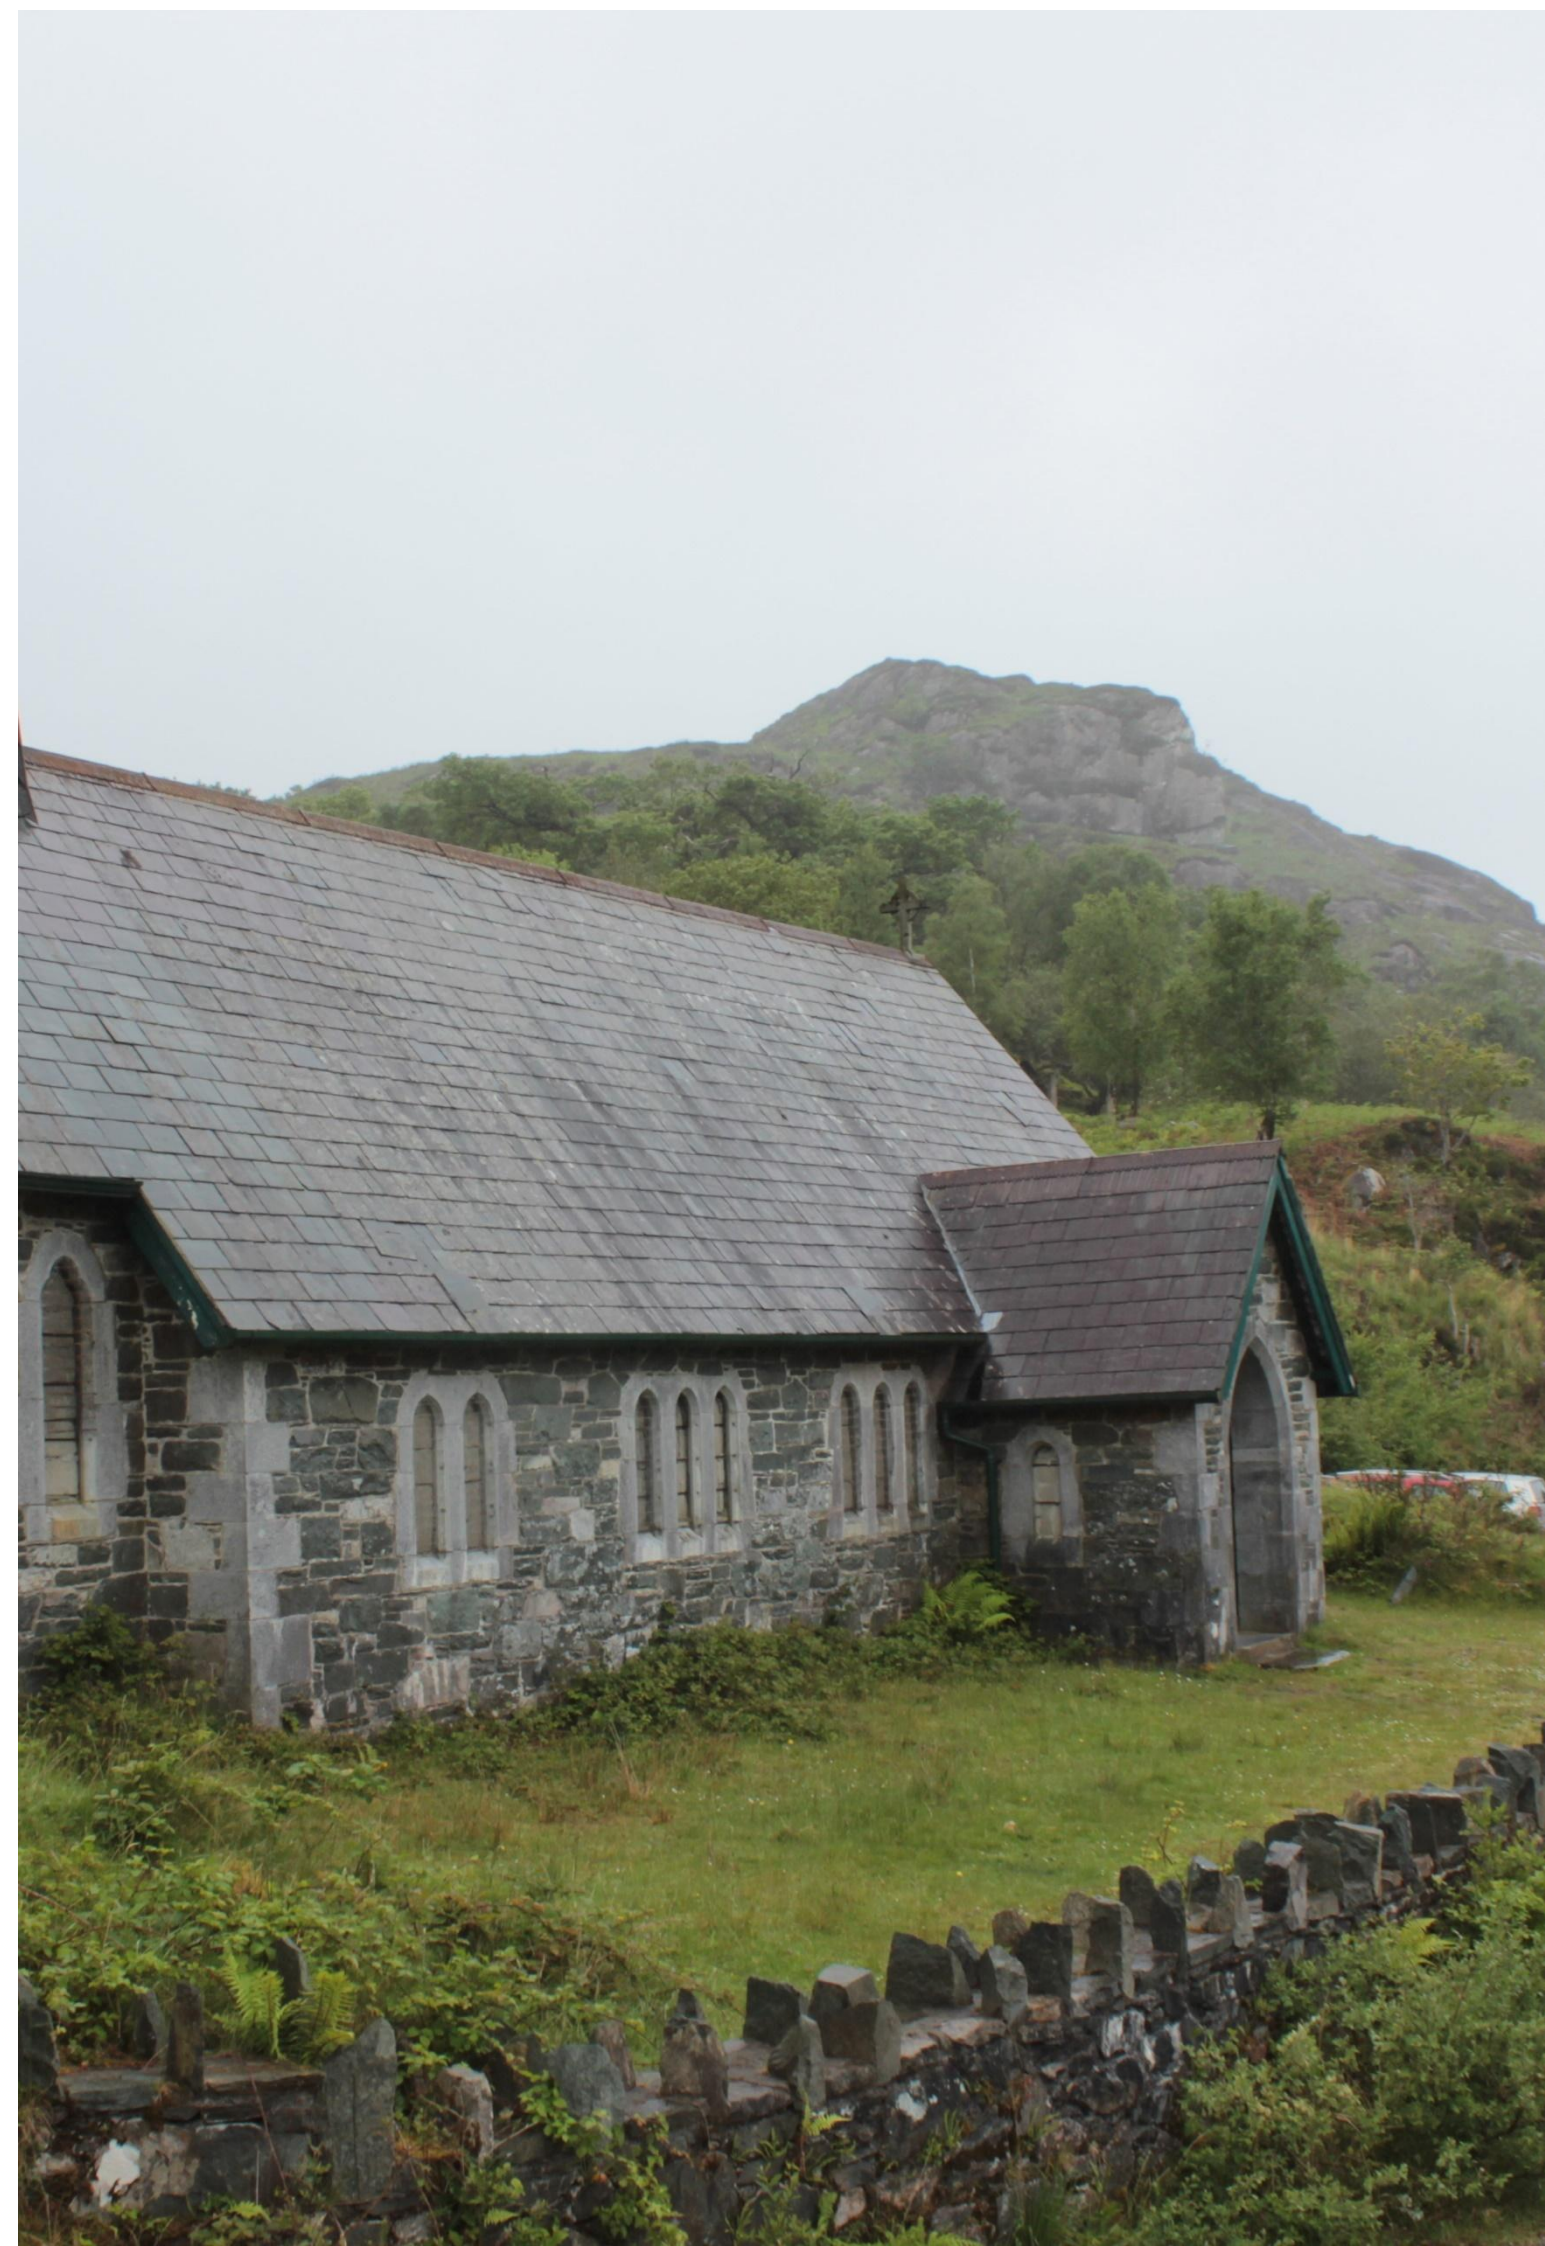
Donadea Castle & Gate

Vacant with no identified new use	
Suffering from neglect and/or poor maintenance	X
Suffering from structural problems	X
Fire damaged	
Threatened with demolition	
Ruin which is poorly maintained	X

Condition of Structure	Ruinous
Level of Risk	High

Donadea and its entrance gates are roofless shells. None of the original fabric remains other than the external walls. It is suffering from structural problems that could lead to full or partial collapse, and there is an immediate threat of further deterioration.

Donadea is a shell of a castellated house belonging to the Aylmer Family of circa 1773 with later additions circa 1827 by Sir Richard Morrison. The castle was deroofed in the 1950s and now forms a focal point for the Coillte owned forest park. The main entrance is through an arched gateway with tower (pictured). The structures are of significant historic importance and requires conservation works to prevent further deterioration.

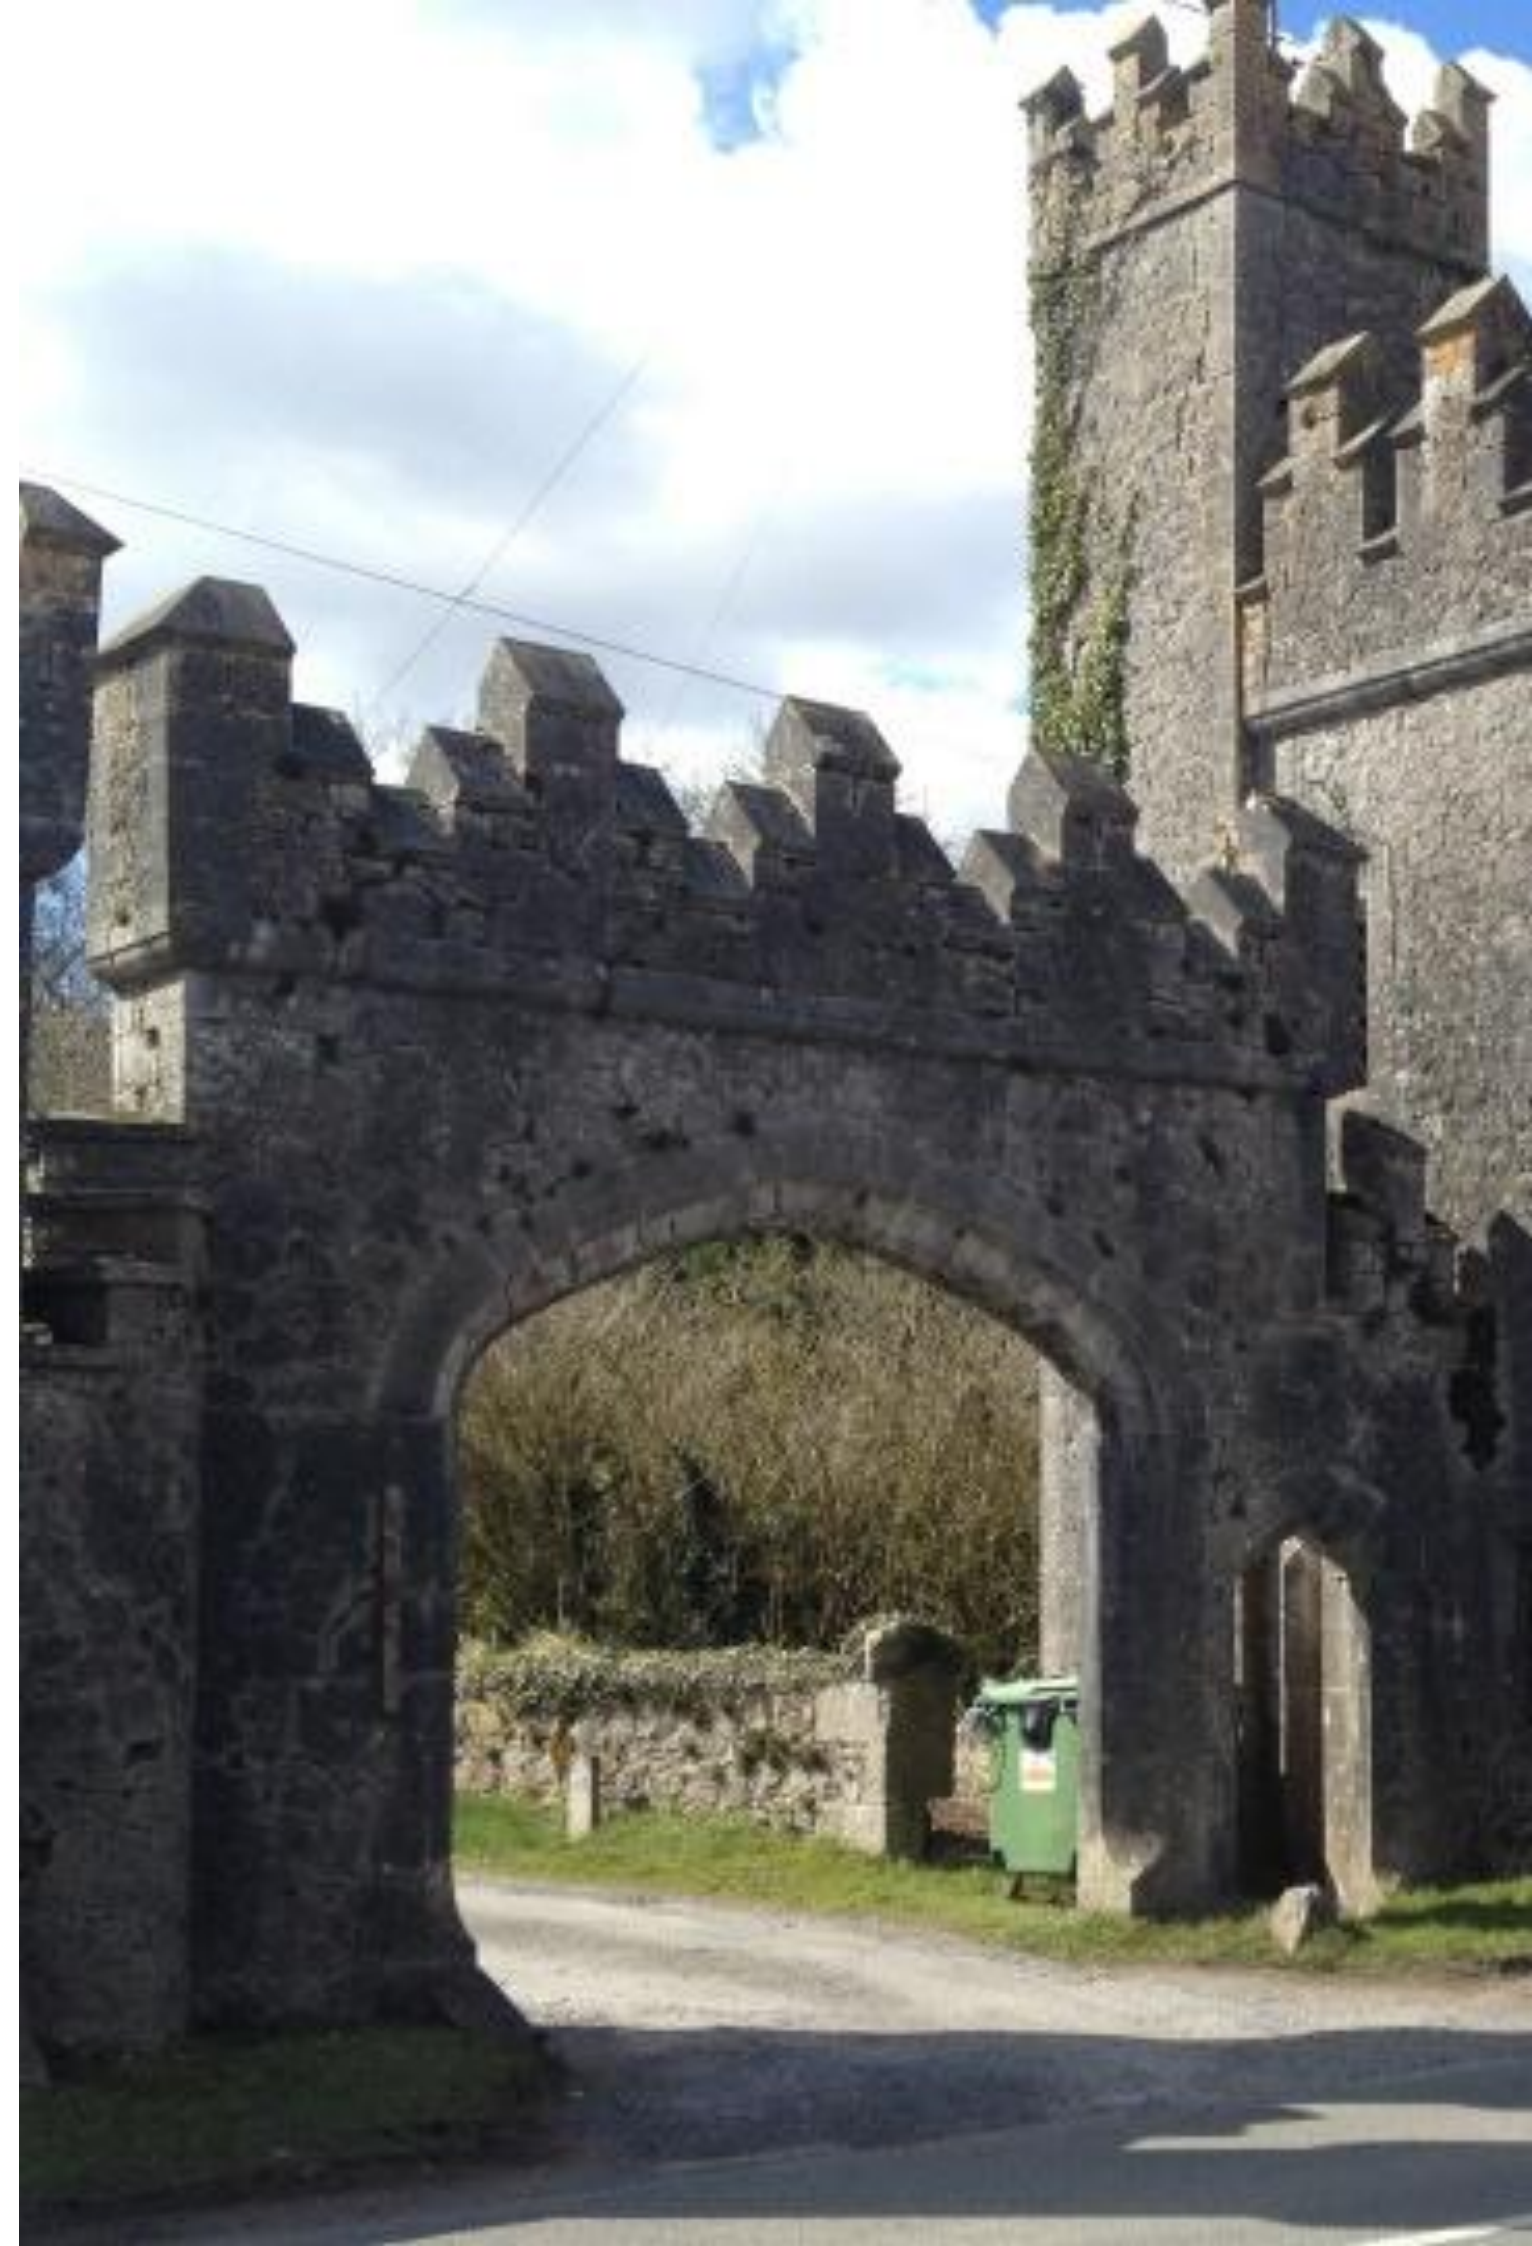
Cassidy's Distillery

Vacant with no identified new use	X
Suffering from neglect and/or poor maintenance	X
Suffering from structural problems	
Fire damaged	
Threatened with demolition	
Ruin which is poorly maintained

Condition of Structure	Very Poor
Level of Risk	High

This building is extensively damaged and suffering from major conservation problems. It is partially roofless with very little of the interior remaining. Most of the external fabric remains, but there is advanced deterioration, particularly water penetration, slipped slates, vegetation growth, broken windows and vandalism.

This impressive complex of industrial buildings dating from establishing of a distillery in 1784 are ideally located in the centre of Monasterevin. A range of new uses should be easily found in such a central location. The mash house with conical dome are architectural features of significant importance and should be central any new proposal put forward for the site.

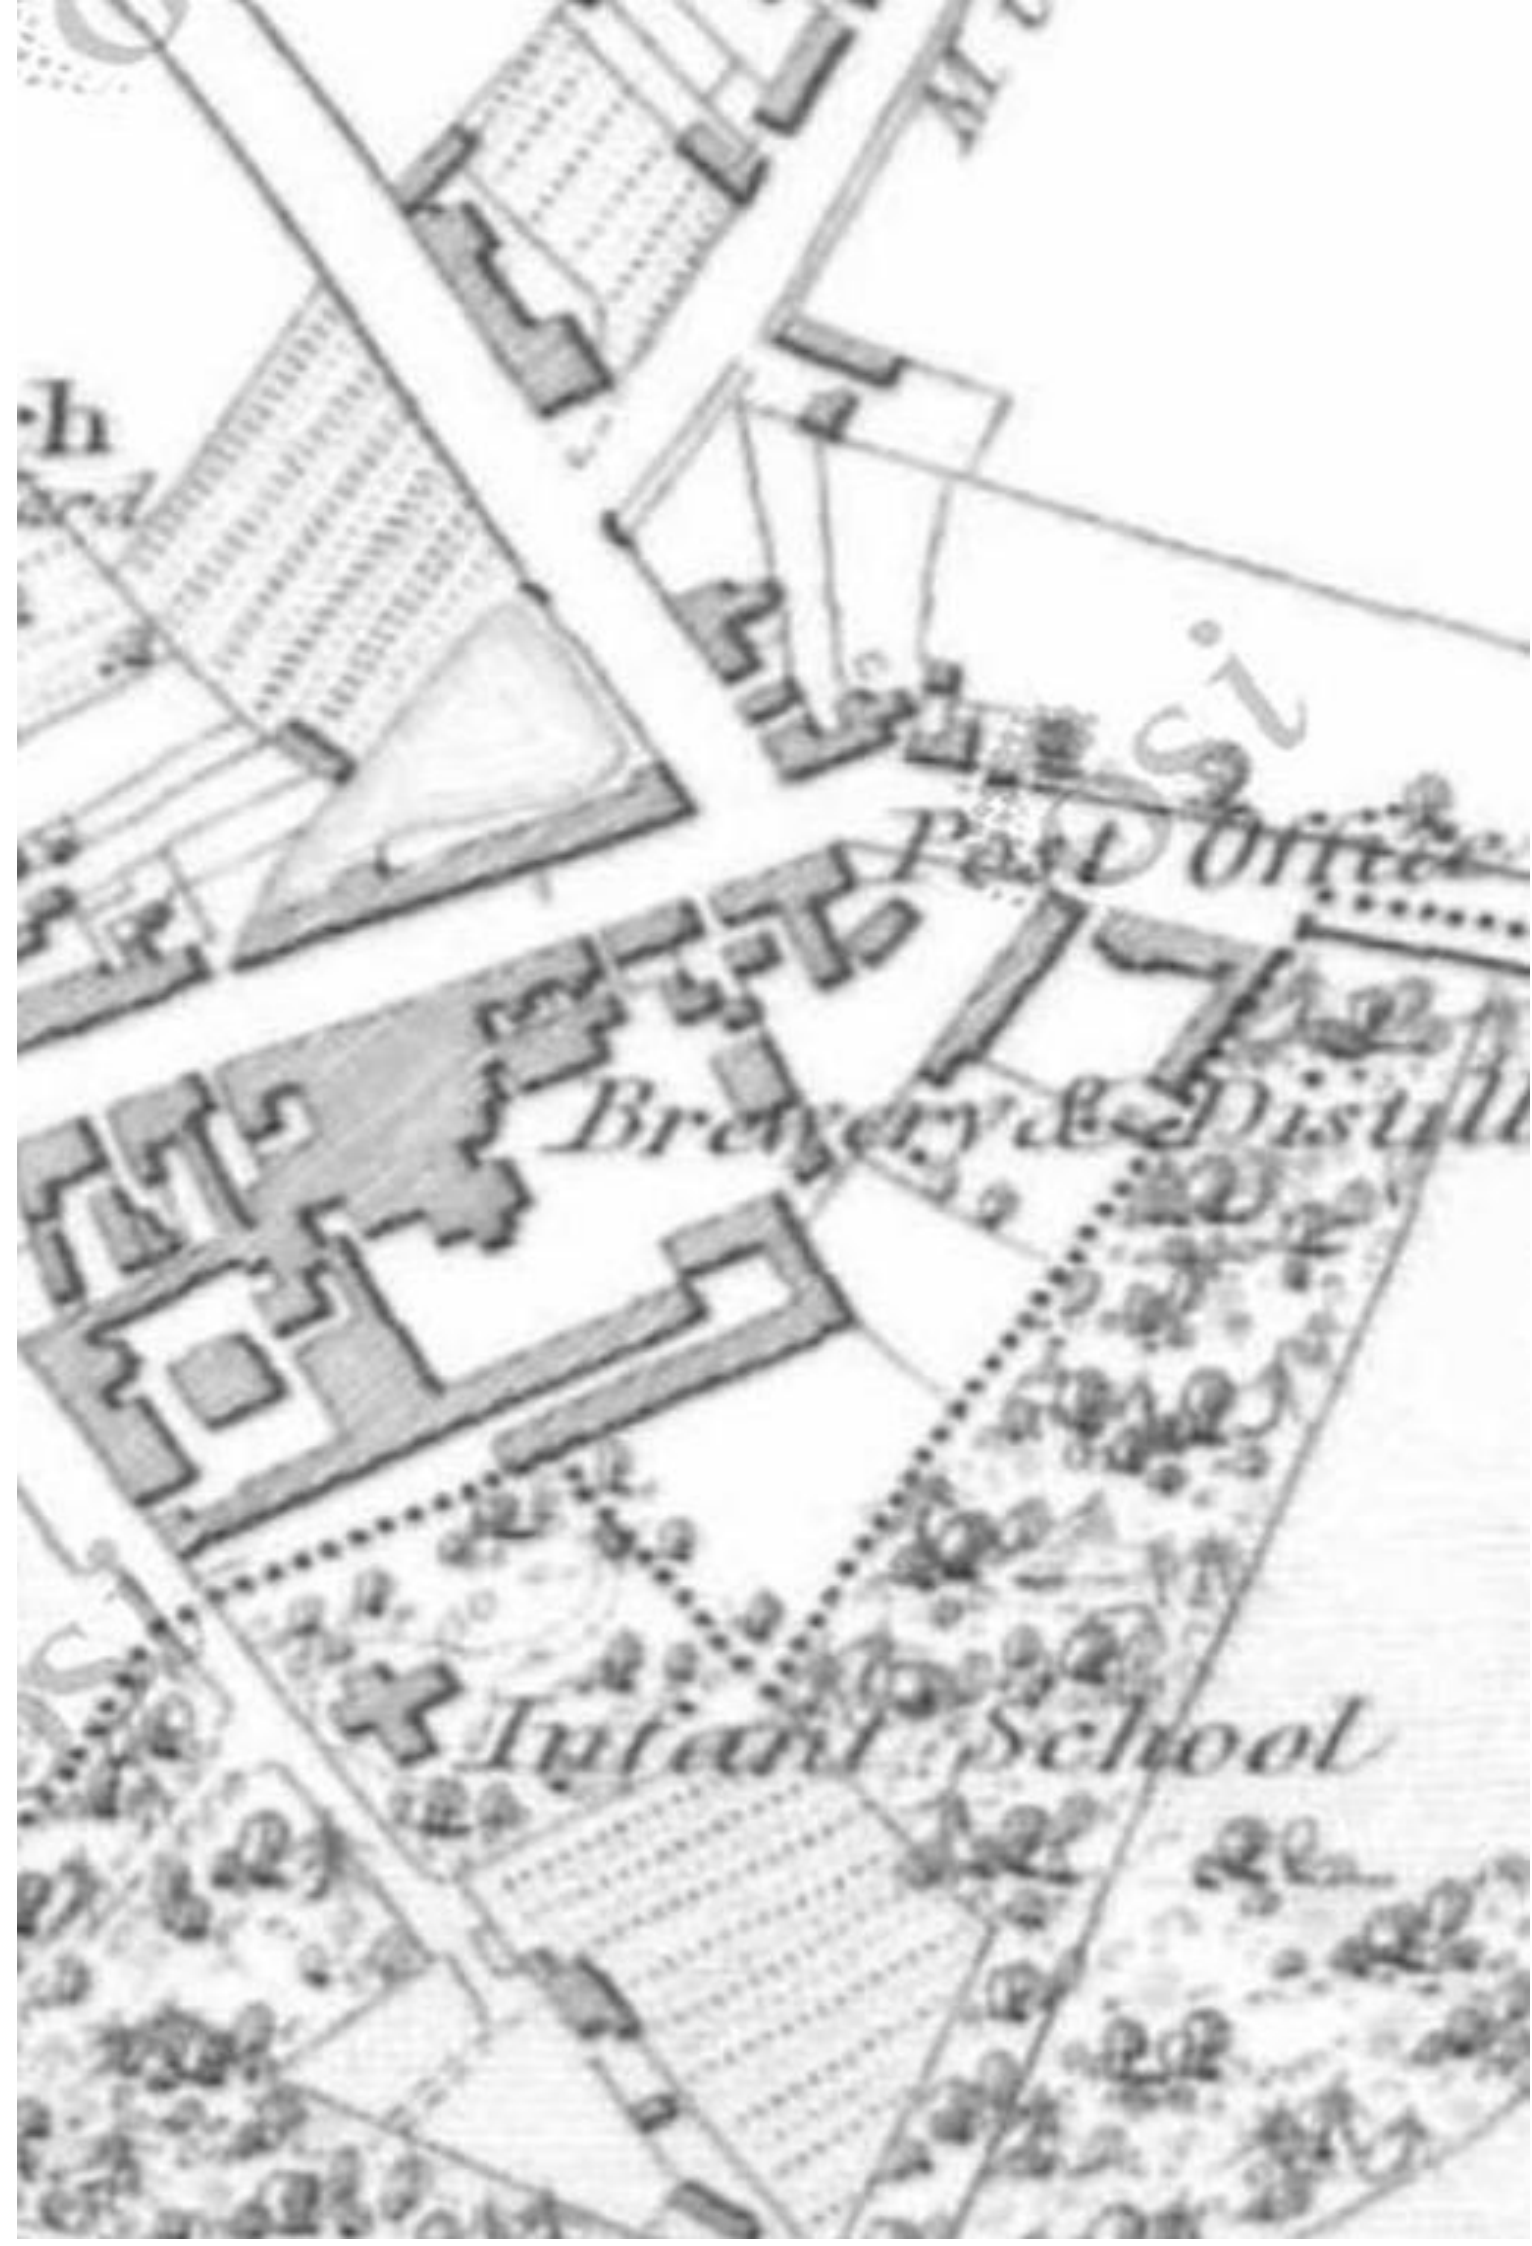
Charter School

Vacant with no identified new use	X
Suffering from neglect and/or poor maintenance	X
Suffering from structural problems	
Fire damaged	
Threatened with demolition	
Ruin which is poorly maintained

Condition of Structure	Poor
Level of Risk	High

This building has been vacant for a number of years and does not appear to be maintained. Most of the external fabric remains, but there are obvious signs of deterioration, particularly water penetration, slipped slates, vegetation growth, broken windows and vandalism. There is no immediate danger of collapse but the condition is such that unless urgent remedial works are carried out the building will sharply deteriorate.

The former school, known locally as the Hulk, is seven bay pedimented from the mid 18th century and one of earliest educational institutions in the area which was sponsored by the Incorporated Society in Dublin for Promoting English Protestant Schools in Ireland. The building was altered to suit a warehouse function in circa 1870 with windows reduced in size. This building urgently requires new uses to be identified to prevent further deterioration of its character.

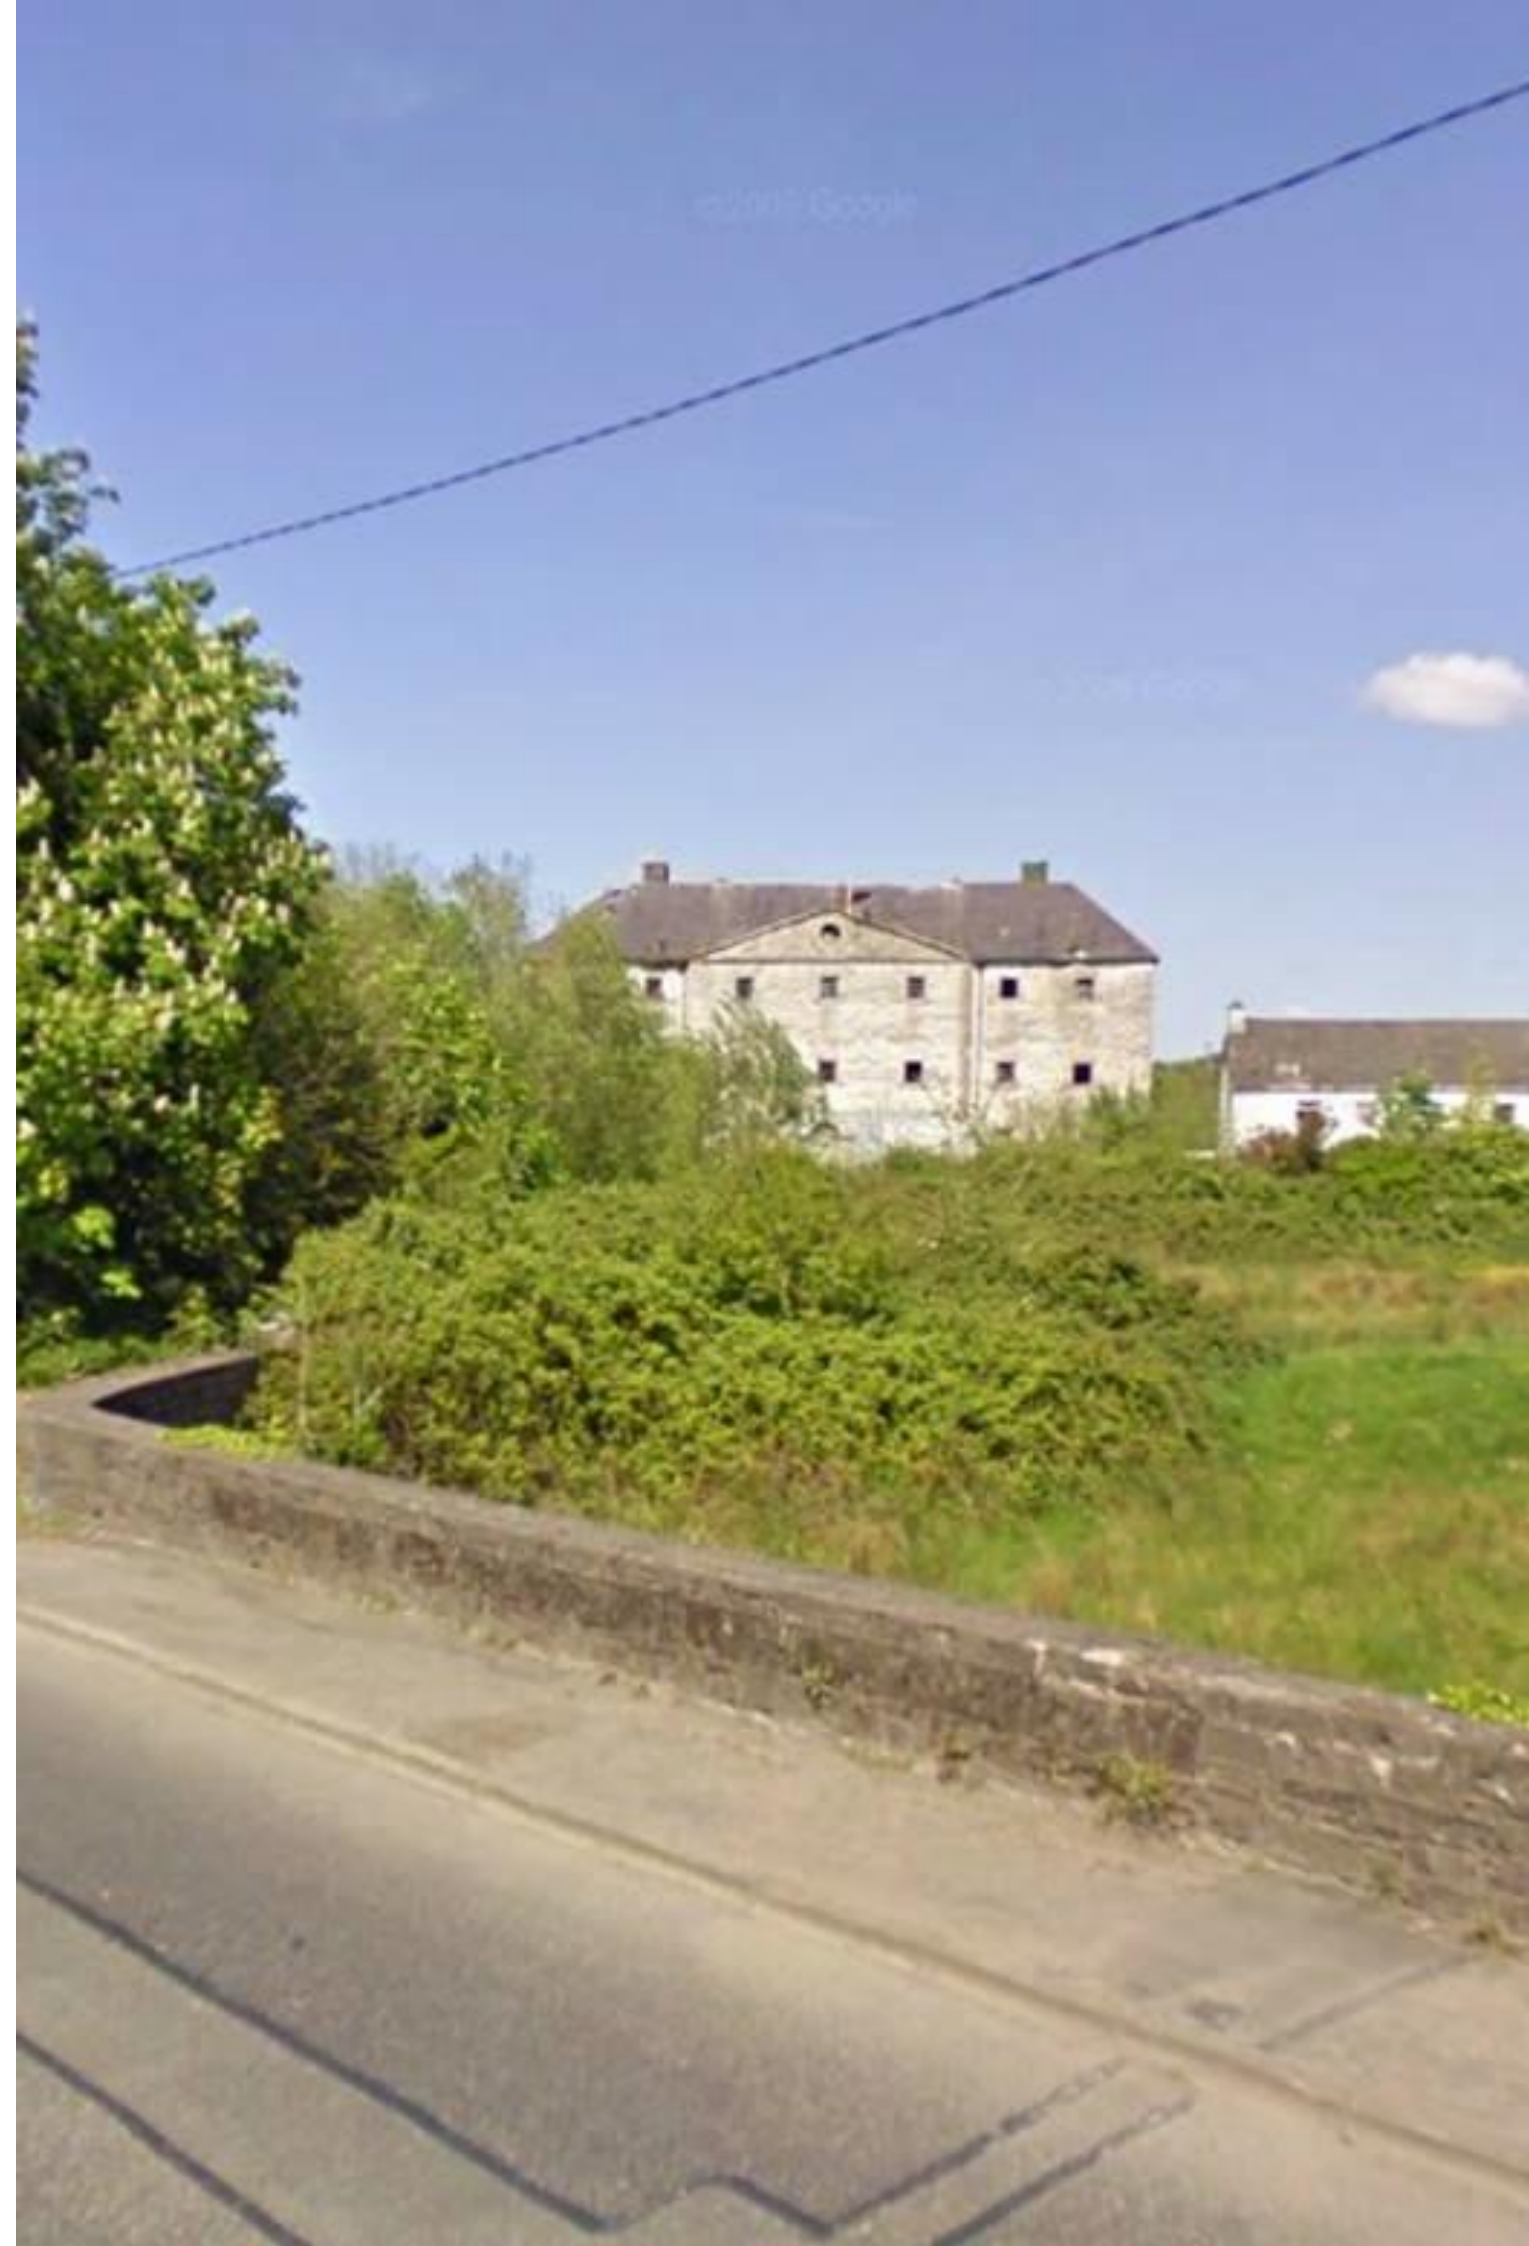
Canal Hotel

Vacant with no identified new use	X
Suffering from neglect and/or poor maintenance	X
Suffering from structural problems	X
Fire damaged	
Threatened with demolition	
Ruin which is poorly maintained

Condition of Structure	Poor
Level of Risk	High

This building has been vacant for a number of years and does not appear to be maintained. Most of the external fabric remains, but there are obvious signs of deterioration, particularly water penetration, slipped slates and vegetation growth. There is no immediate danger of collapse but the condition is such that unless urgent remedial works are carried out the building will sharply deteriorate.

Having operated as a hotel for many years, the structure was converted to a museum/gallery at the end of the 20th century. A building of such local significance, with such a close connection to the Grand Canal, should be brought back to active use as a matter of priority.

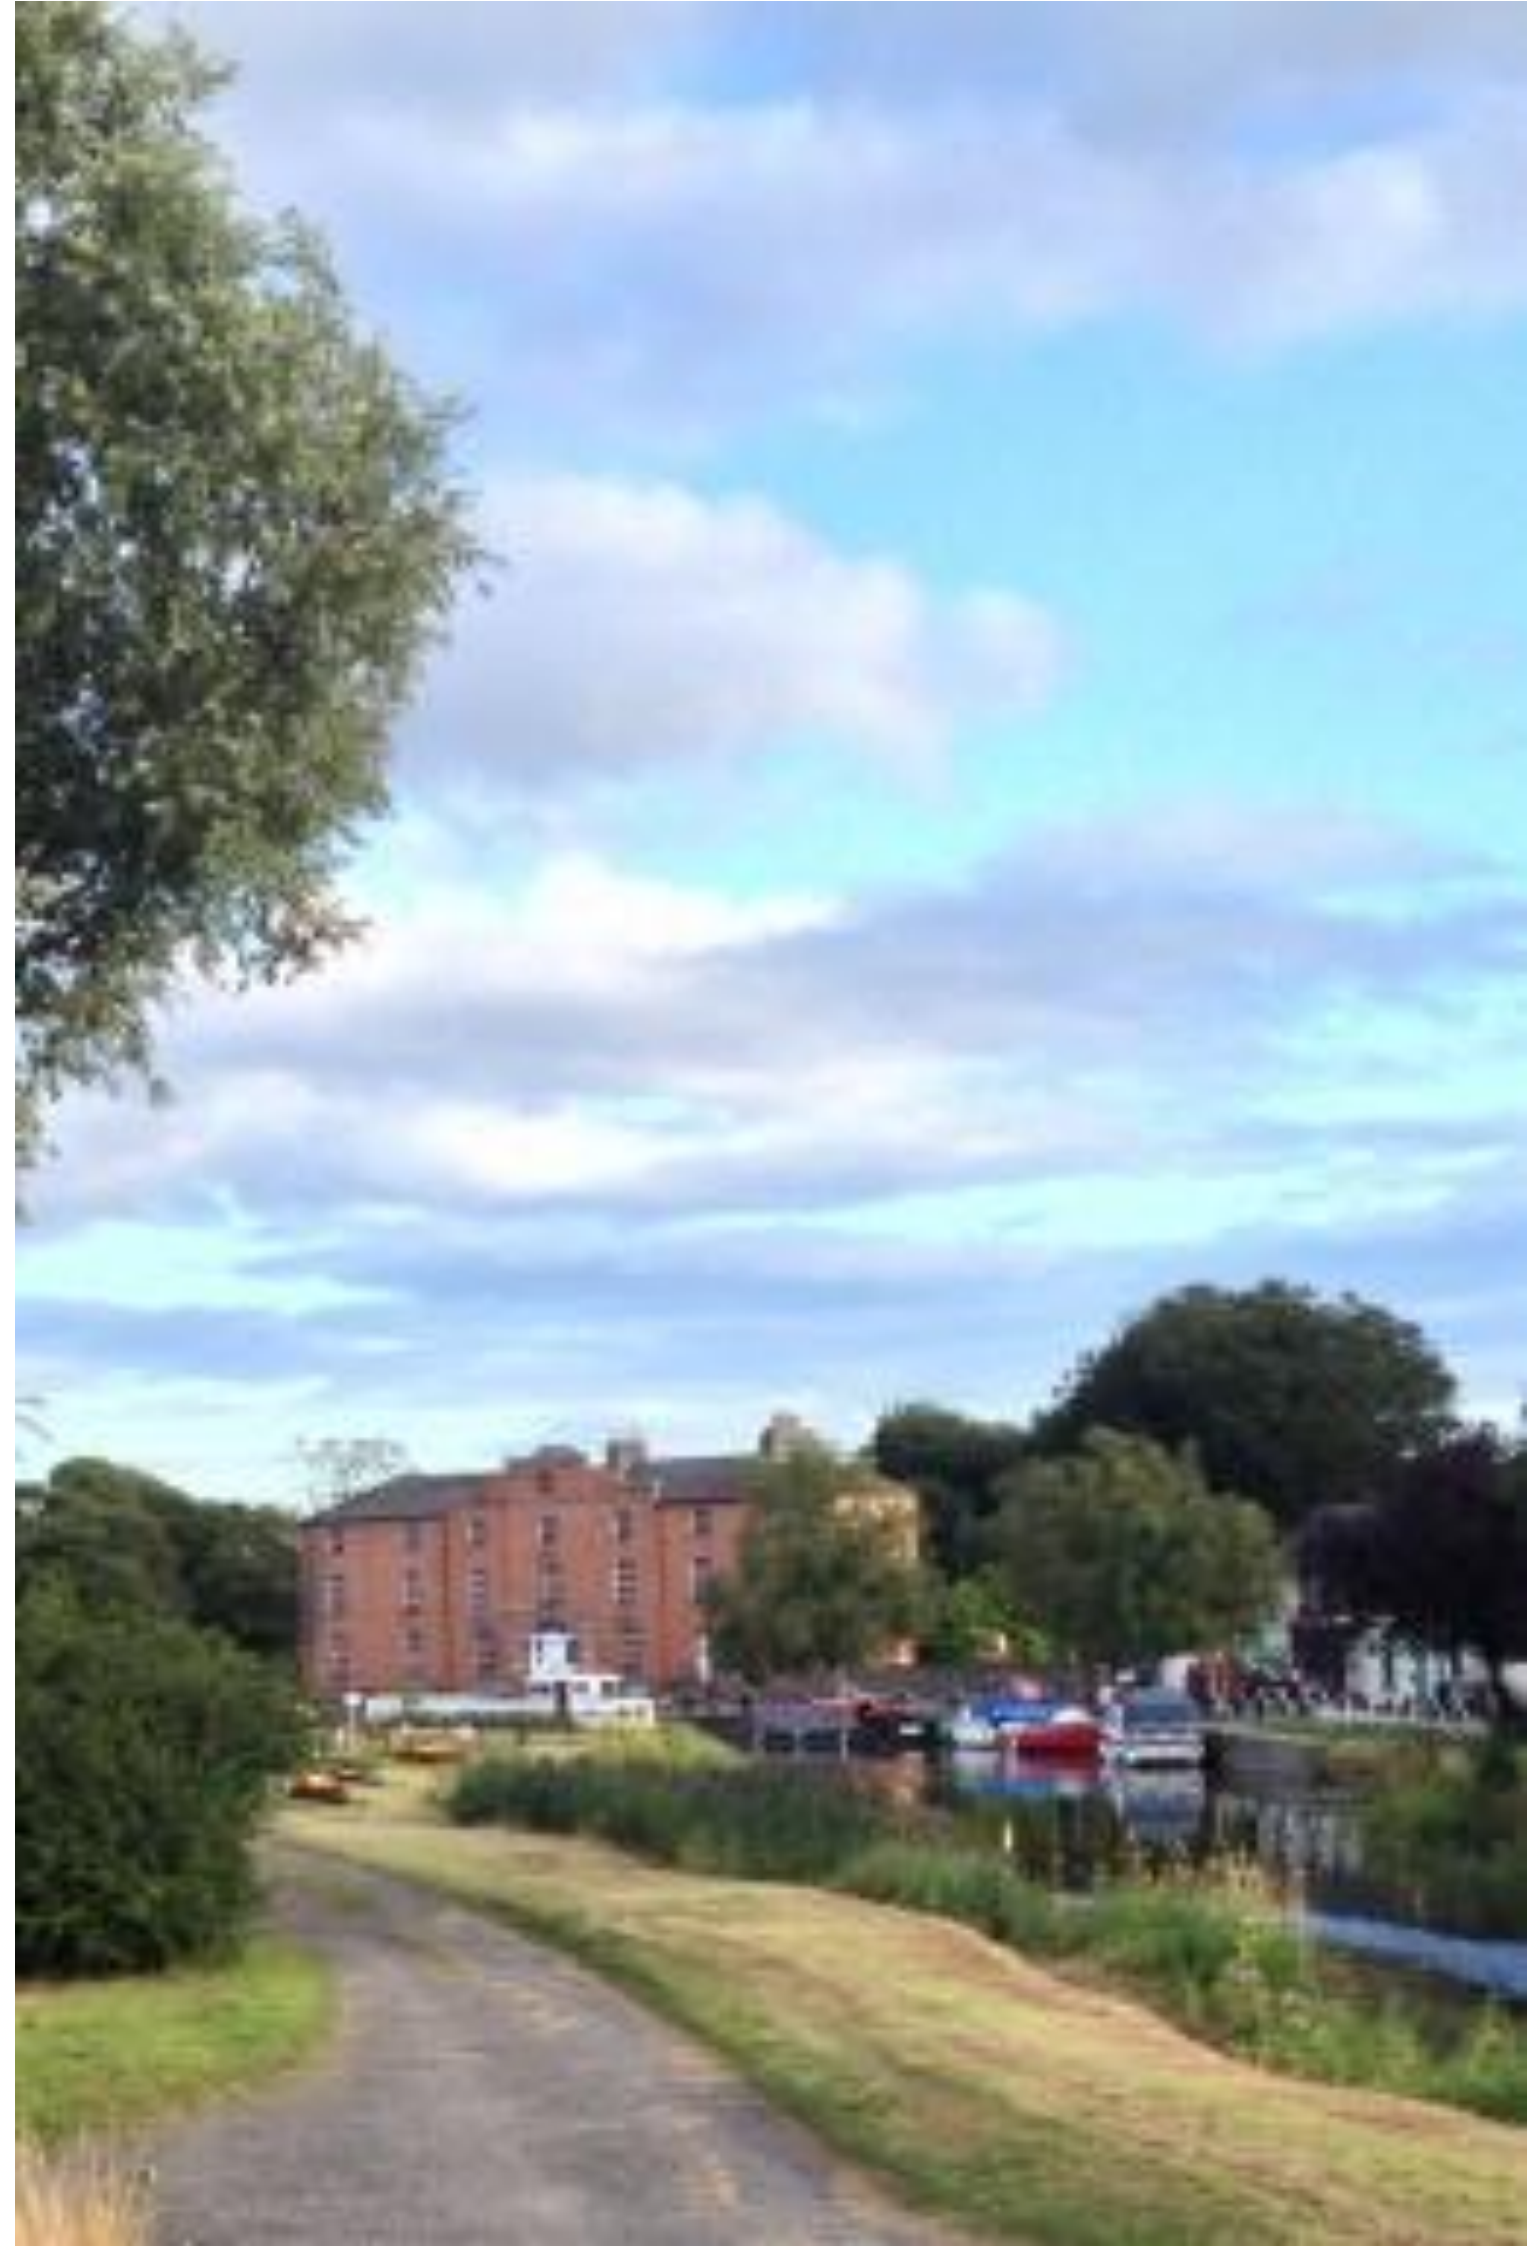
Barrow Viaduct

Vacant with no identified new use	
Suffering from neglect and/or poor maintenance	X
Suffering from structural problems	X
Fire damaged	
Threatened with demolition	
Ruin which is poorly maintained

Condition of Structure	Fair
Level of Risk	High

The structure does not appear to be maintained and there are obvious signs of deterioration. There are concerns that the structure could suffer further decay leading to more serious problems.

The Benjamin Baker design links the counties of Wexford and Kilkenny. It is the longest railway bridge in Ireland at 650m long. It has become at risk given its disuse to commercial rail traffic in 2010, when the Rosslare to Waterford line closed. While no new use would be proposed for the structure, a conservation management plan should be applied to it, to help preserve our rail heritage.
